## 7.0 ARCHAEOLOGY

### 7.1 EXCAVATION IN ROOM 103

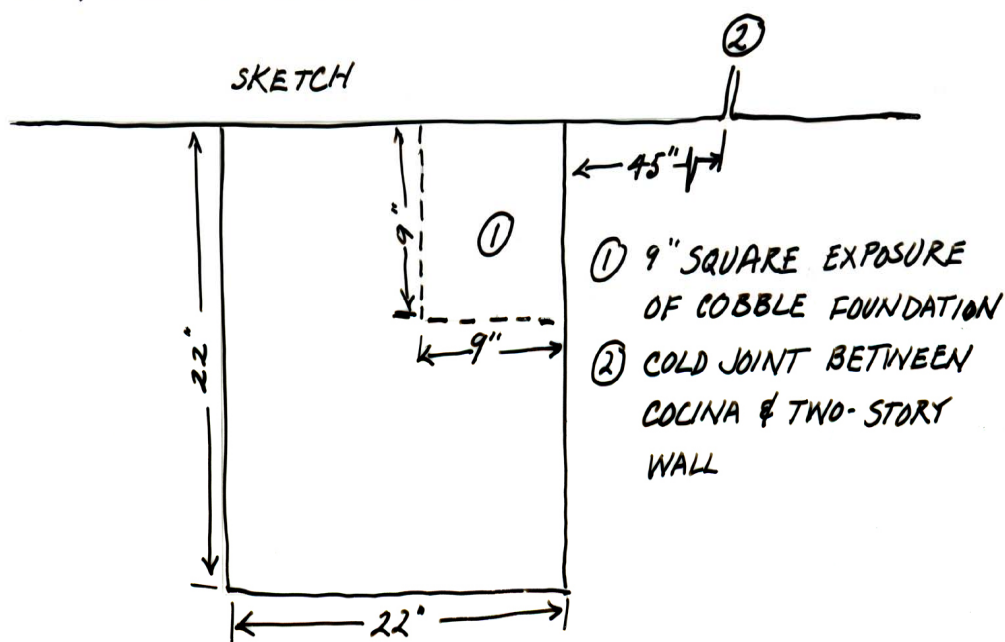
Figure 7.3 Plan of unit next to west exterior wall.

The archaeological test for the foundation of Room 101, the cocina, had to be made on the exterior because the interior has a paved floor. The small unit was located against the base of the west wall, 3'-9" north of the joint between rooms 101 and 102. **Figure 7.3** shows the lay-out. The existing grade, that is bare soil along the west side of the cocina, is at the same level as the surface of the pavers that start 34" out from the wall, so the surface of the hard material was used as the datum for vertical measurement. This gives a reference point that will be present in the future. Therefore measurements above the pavers are plus and those below it are minus.

At the base of the wall, a concrete ledge (profile sketched in Figure 7.4) was broken out within the unit in order to expose the full foundation. This irregularly shaped concrete repair might be considered to be a contrapared. It lips up the wall 2 to 3"; the roughly triangular shape rests against an irregular wall surface that does not look like coving from basal erosion. This is probably an attempt to keep surface water away from the base of the wall.
